# Manhole Inspection Summary

Manhole # S29EE1027MH

Insp Date: **12/15/06 12:49 PM**

**Location** Address: **3900 BEECH AVE**

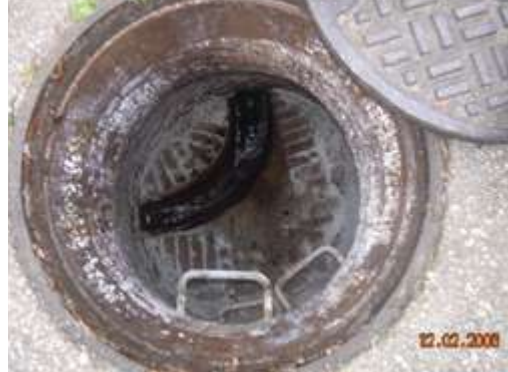
Top View

Bench debris.

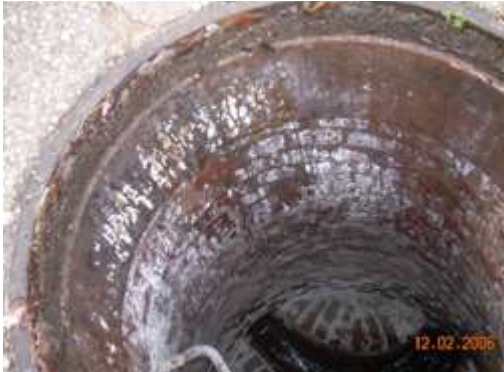
Defect

☒ **Leaks**

Infiltration: ☐ None ☒ **Joint** ☐ Cracks ☒ **Mortar** ☐ Roots ☐ Wall

Frame leaks. Adjustment infiltration.

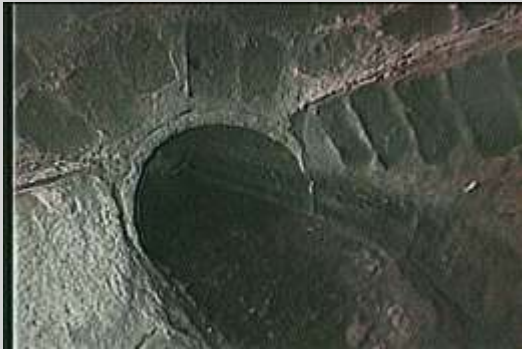
### 8 in. Circular Gravity Sewer Pipe Out @ 12 O'Clock

Deposits: ☐ None ☒ **Mud** ☐ Sludge ☒ **Debris** ☐ Grease

Silt Depth: **0.5** (in.) Deposits Extent: **Light**

Infiltration: **Evidence** Pipe Seal Cond: **Unknown**

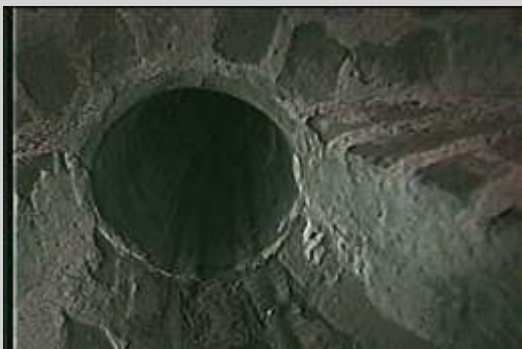
### 8 in. Circular Gravity Sewer Pipe In @ 9 O'Clock

Infiltration: **Evidence** Pipe Seal Cond: **Unknown**
